Inspection Report Minerals Regulatory Program May 30, 2013

Mine Name: D-TractPermit Number: S/047/0068Operator Name: Uintah Basin ResourcesInspection Date: May 30, 2013Inspector(s): April Abate & Paul BakerTime: 2:00 PMOther Participants: NoneMine Status: Active

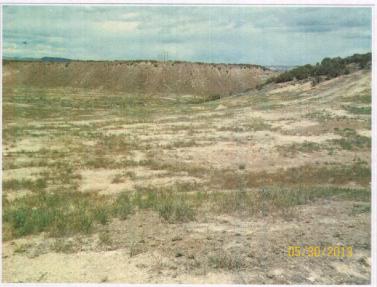
No mining activity was observed during the time of inspection at the site. According to Paul, the operator has begun reclamation by backfilling the pit area. The operator reportedly seeded the area in the spring of 2011; however the seeding did not appear to take very successfully.

View of backfill reclamation of the pit area. Vegetation growth is spotty.

The operator should attempt to seed the area in accordance with the reclamation guidelines outlined by the Division and posted on the Division's website. Until the operator can demonstrate three successful growing seasons, a full bond release cannot be granted. See manual on the Practical Guide to Reclamation in Utah:

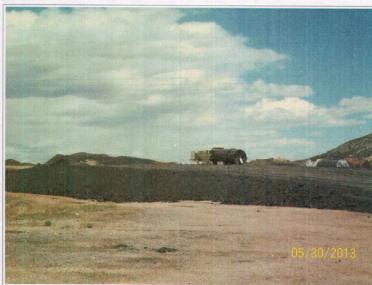
Current activity at the site.
